WESTCOTT RESERVOIR
ONONDAGA COUNTY
NEW YORK

INVENTORY No. NY 1471

PHASE I INSPECTION REPORT
NATIONAL DAM SAFETY PROGRAM

MAY 1981

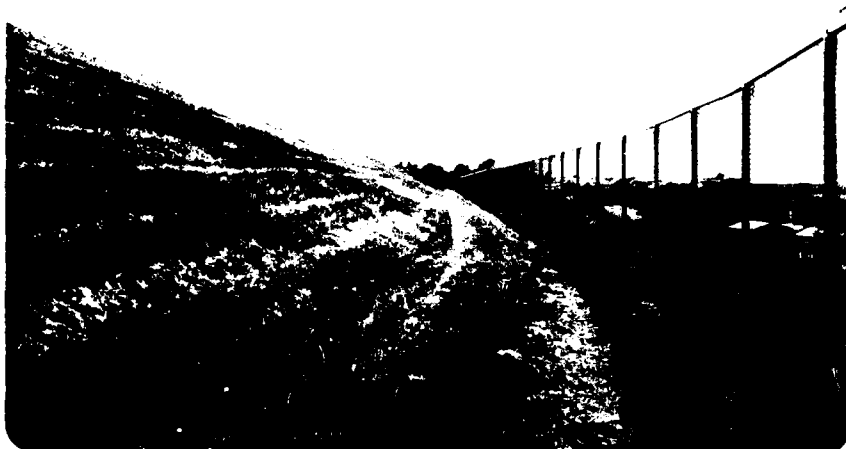
4. Easterly slope of embankment.

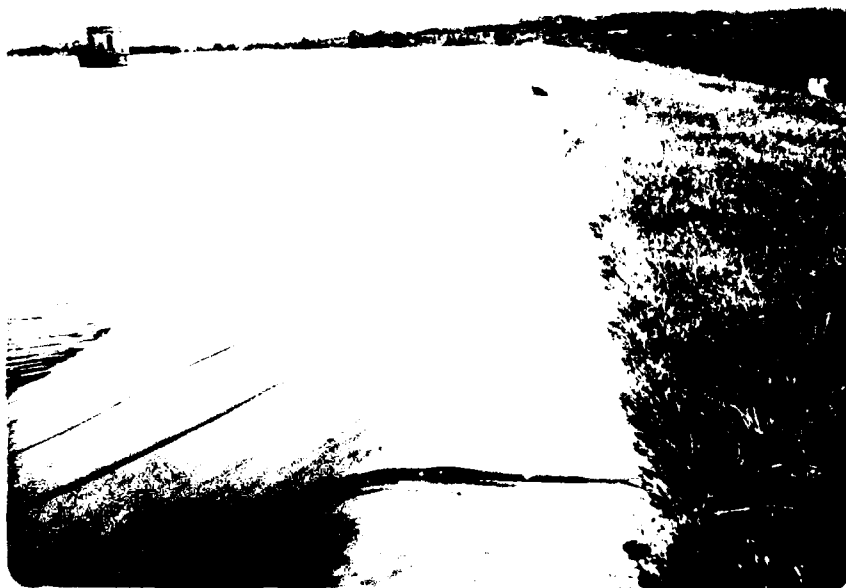
1. Seepage was detected near the toe of the slope of the northwest embankment.
2. Minor tears exist in the hypalon lining near the top of the embankment.
3. No warning system is presently in effect to alert the public should conditions occur which could result in failure of the dam.
4. No formalized inspection system is in effect at the facility.

5. Closeup of hypalon lining.

1. Seepage near the northwest toe of slope should continue to be monitored and data recorded to enable observers to detect changing conditions.
2. Tears in the hypalon liner should be repaired.
3. A flood warning and emergency evacuation system should be implemented to alert the public should conditions occur which could result in failure of the dam.
4. A formalized inspection system should be initiated to develop data on conditions and maintenance operations at the facility. Specifically, data should be collected and recorded regarding flow from the sub-drain system of the facility.

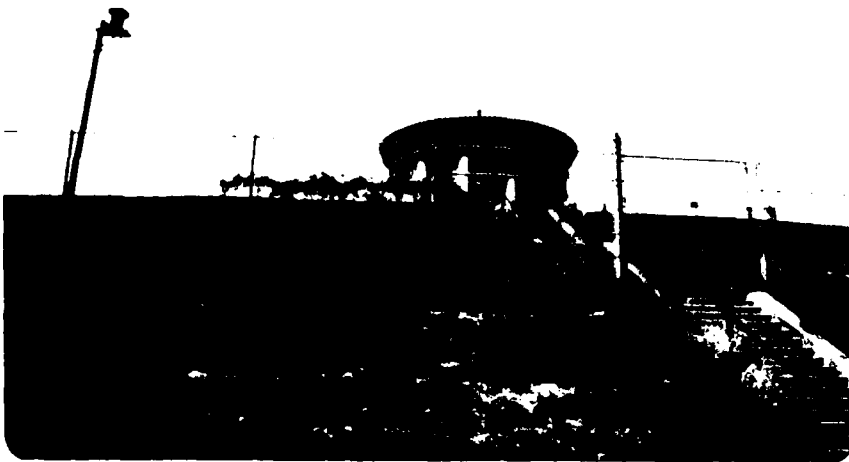
The gatehouse at the toe of the slope to the south of the impoundment was found to be in operating condition and generally in good repair.

6. Gatehouse at south end of reservoir.

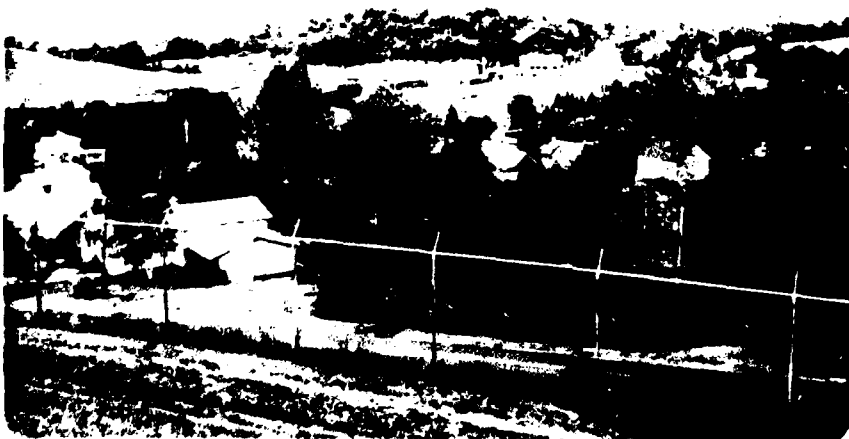
The impoundment is located immediately adjacent to a heavily developed residential section of the Town of Geddes. Therefore, the dam is in the high hazard category as defined by the Recommended Guidelines for Safety Inspection of Dams.

8. View from toe of slope illustrating "downstream" hazard.
